Technical Service Bulletin

69 Front seat belt twisted

69 20 47 2058455/1 February 6, 2020.

Model(s)	Year	VIN Range	Vehicle-Specific Equipment
A6, A7, A8, Q8, and Audi e-tron quattro	2019 - 2020	All	Not Applicable

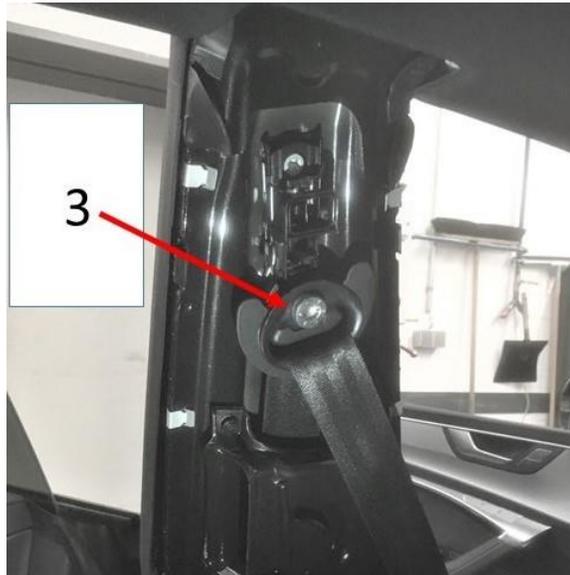
Figure 1. Seat belt deflector at height adjuster with B-Pillar trim removed.

1. Remove the upper B-Pillar trim on the affected side according to the repair manual.
2. Remove the bolt of the seat belt deflector (Figure 1, Pos. 3).

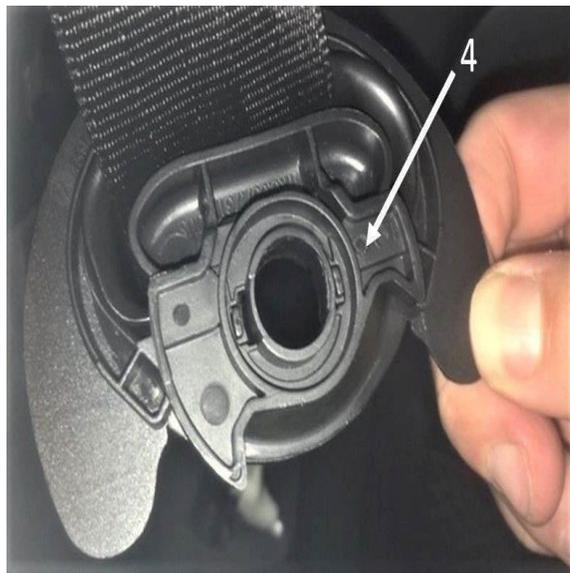
Figure 2. Backside of seat belt deflector. Deflector trim tabs engaged in old belt guide.

5. Install the modified belt guide 4K8 857 799 on the front driver side and 4K8 857 800 on the front passenger side (Figure 2, Pos. 4).

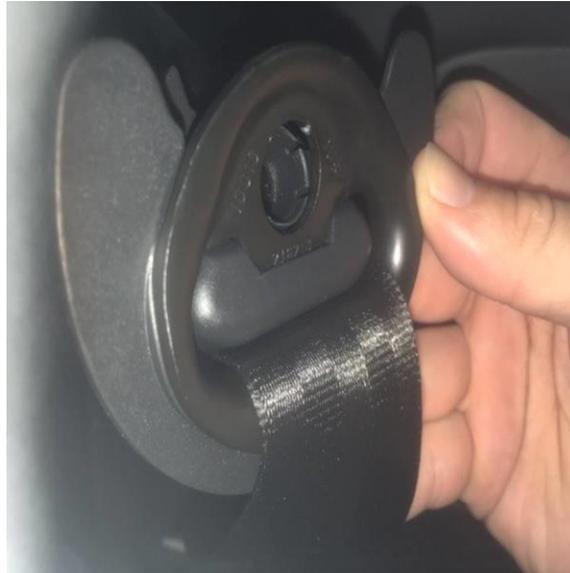
Figure 3. Removing old seat belt guide starting at the bolt hole.

3. Use your thumb to remove the old belt guide (plastic part) from the steel deflector. Start by detaching the guide from the bolt hole, then press out the lower section covering the metal tab (Figure 3).

Do not use sharp objects to remove the old belt guide to avoid damaging the seat belt webbing.

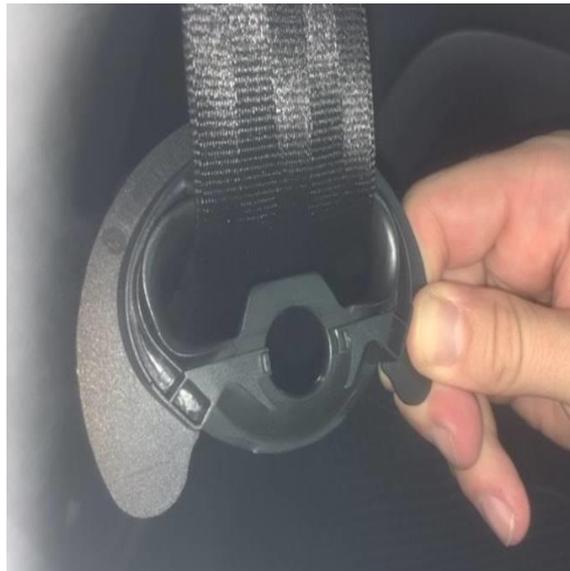
Figure 4. Old seat belt guide removed. Seat belt twist corrected.

4. With the old belt guide removed, turn the seat belt webbing to remove the twist (Figure 4).

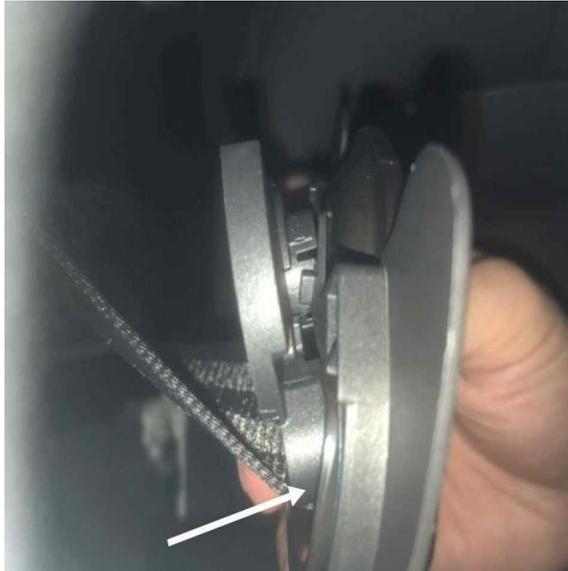
Figure 5. Installing modified seat belt guide starting with the metal tab on the bottom.

6. Start installing the modified seat belt guide at the deflector metal tab (Figure 5).

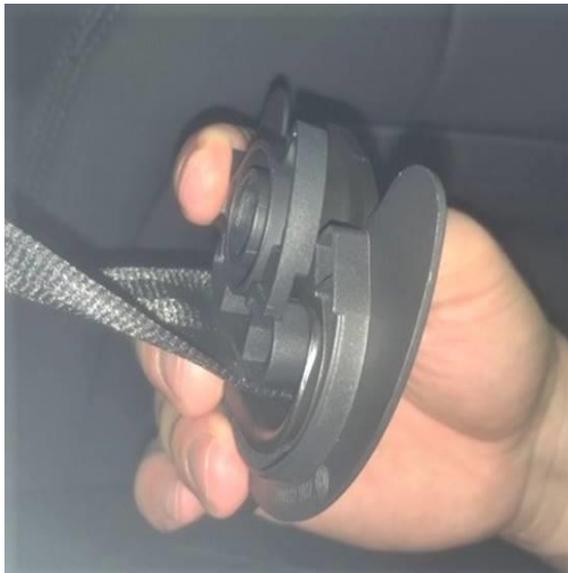
Figure 6. Seat belt deflector with new guide installed.

7. Push the new guide into the bolt hole until you can hear the plastic retainers snap into place (Figure 6).

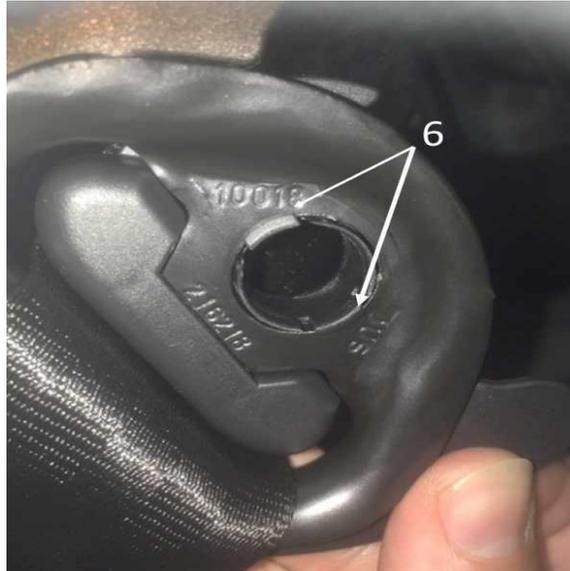
Figure 7. Belt guide locking tabs correctly secured at bolt hole.

8. Inspect the front of the deflector for proper installation of the guide locking tabs at the bolt hole (Figure 7, Pos. 6)

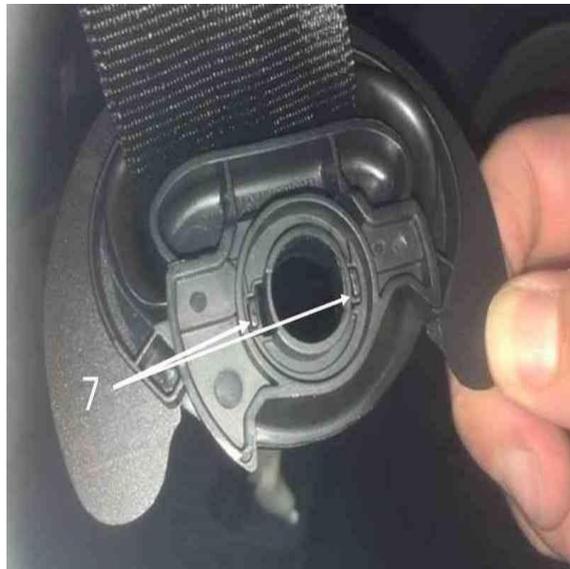
Figure 8. Seat belt deflector trim locking tabs properly secured to seat belt guide.

9. Inspect the back of the deflector for proper installation of the deflector trim locking tabs to seat belt guide (Figure 8, Pos. 7)
